# Chapter 5: STA Performance, Compliance and Optimization

Kathleen Pietro, Ron Bearzotti, Michael Chimney,  
Guy Germain, Nenad Iricanin and Tracey Piccone

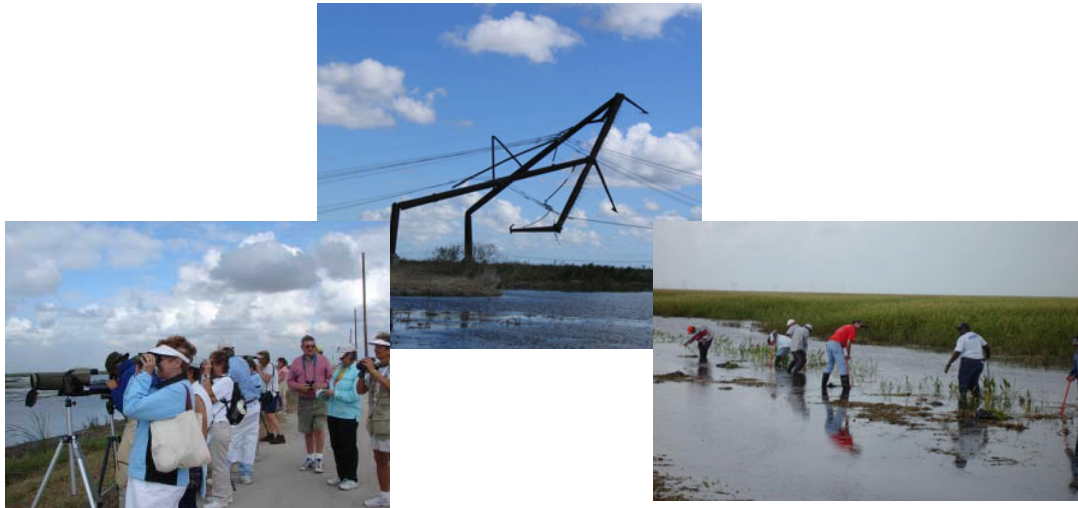
**Figure 5-2.** Avid bird watchers flock to the STAs (left). Recreational opportunities in the STAs include bird watching, hunting, and hiking. The impacts of Hurricane Wilma included damage to the submerged aquatic vegetation (SAV) and damage to the high voltage electrical lines (center). Vegetation strips were planted in STA-1W Cell 5 to protect the SAV from wind and wave damage (right).

- Hurricane Wilma impacted all the STAs, resulting in widespread loss of power and damage to the levees and plants (**Figure 5-2** and each STA section).

Hurricane Wilma affected levees, structures, power, vegetation, and water clarity in the STAs (**Figure 5-2**). Most structures lost power during the storm and experienced minor damage. Wooden and high voltage poles were broken, some telemetry to the structures was lost with the power outage, and auto-samplers and intakes were damaged by high winds and wave action. The hurricane also adversely affected the vegetation, especially the SAV communities, creating poor water clarity and high turbidity. All SAV and open water treatment cells experienced turbidity problems, whereas STA-1W Cell 5B and STA-2 Cell 3 experienced severe turbidity problems. Those treatment cells with damaged SAV communities had highly turbid water, unconsolidated sediments, increased water column TP concentrations, and little to no plant reestablishment. The effects of the hurricane impacts prompted efforts to fortify the marsh to increase plant survivability and the implementation of a “lost power” scheme for both pre- and post-storm operations. In STA-1W Cell 5B, emergent vegetation strips were established to help prevent vast SAV migration across the marsh and reduce the impact of wave action.

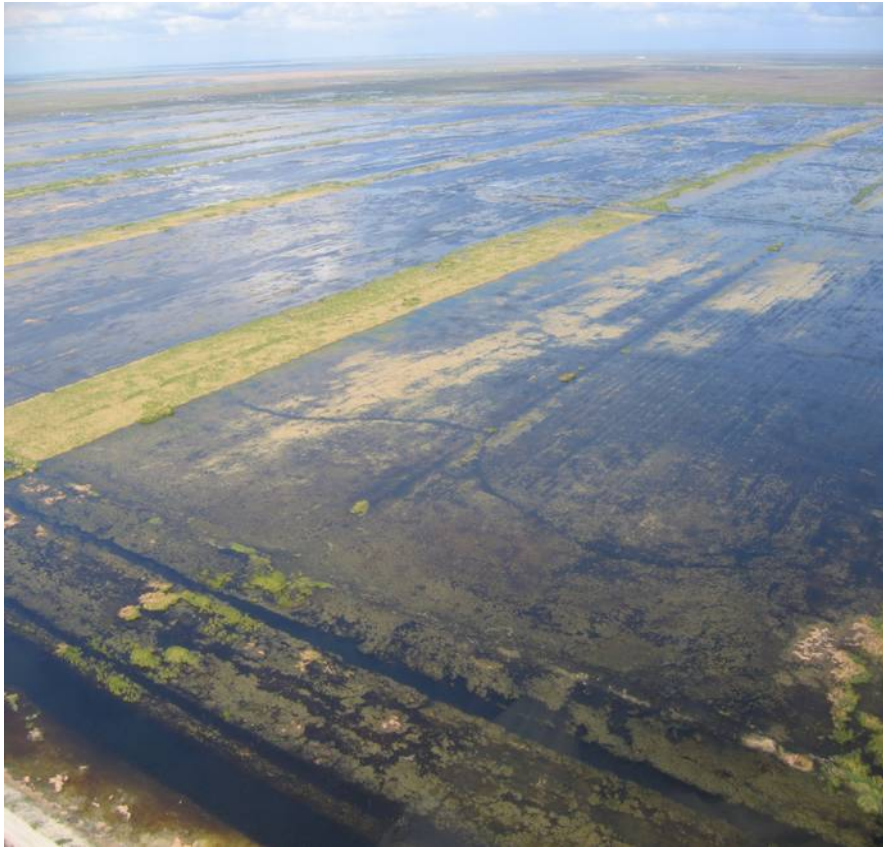
**Figure 5-36.** Vegetation strips, consisting of emergent plants, serve as wind and wave barriers to fortify the SAV communities against large storm events.

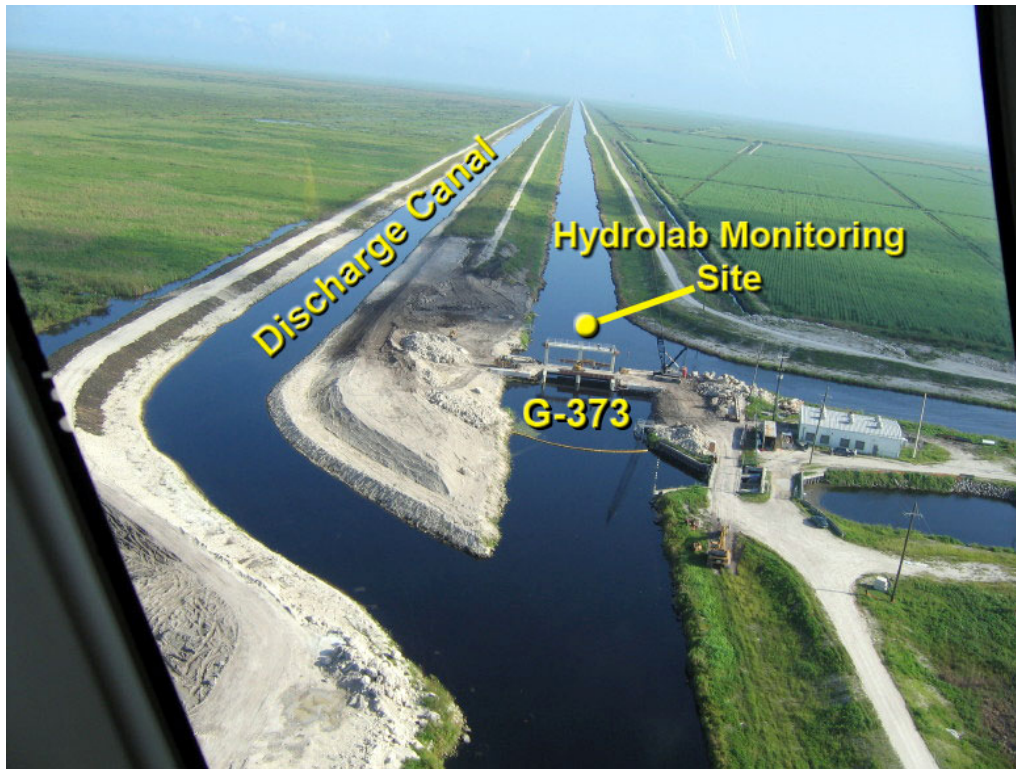
**Figure 5-46.** Location where extended discharge canal from STA-5 connects to Miami Canal, south of structure G-373.

During July 2005, the discharge canal outflow point to the Miami Canal between the North Miami Canal (NMC) and South Miami Canal (SMC) monitoring sites was filled in. The discharge canal was extended southward and connected with the Miami Canal below structure G-373 (**Figure 5-46**).
