# **Appendix 5-1: Annual Permit Report for the North Palm Beach County - Part 1 Project, G-160 and G-161 Components**

**Permit Report (Operational Year 2009)  
Permit Numbers: EI 50-0128848-004 and EI-0244327-002**

**Comprehensive Report on Results of 5-Year Operation  
Monitoring Program for the G-160 and G-161 Projects  
FINAL  
02/12/2010**

# **Loxahatchee Slough Restoration and G-160 Monitoring Plan First Post Operation Field-based Vegetation Monitoring Report**

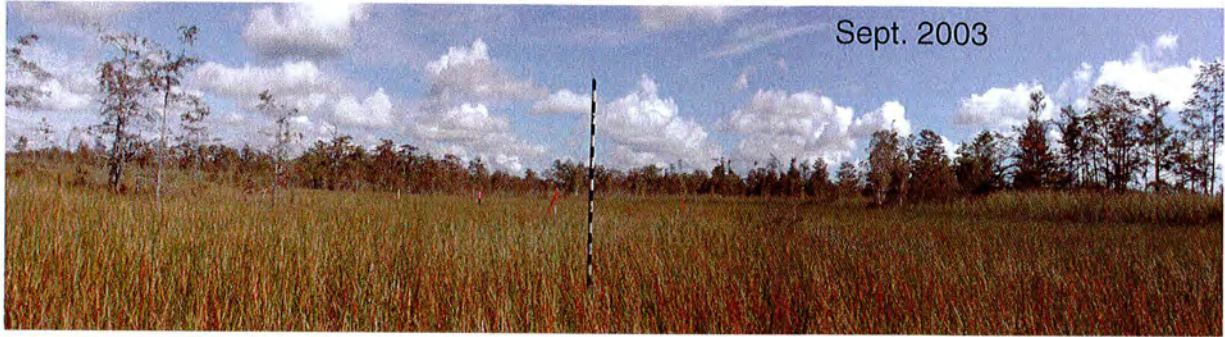
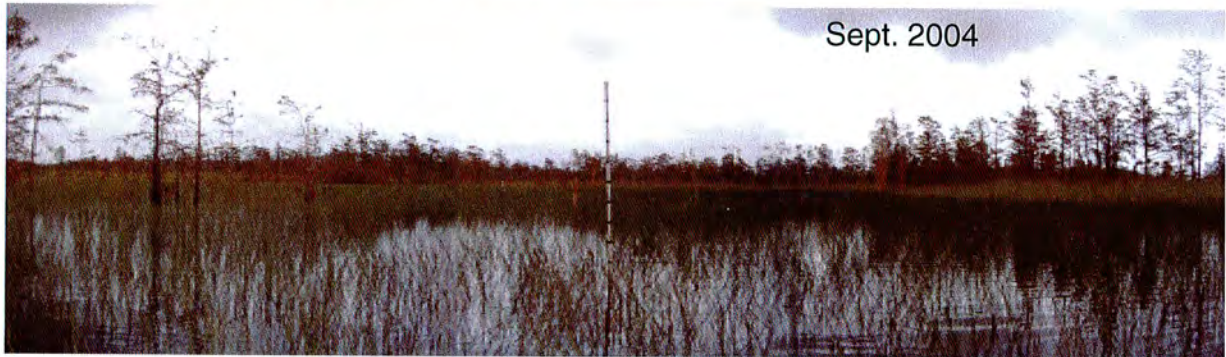
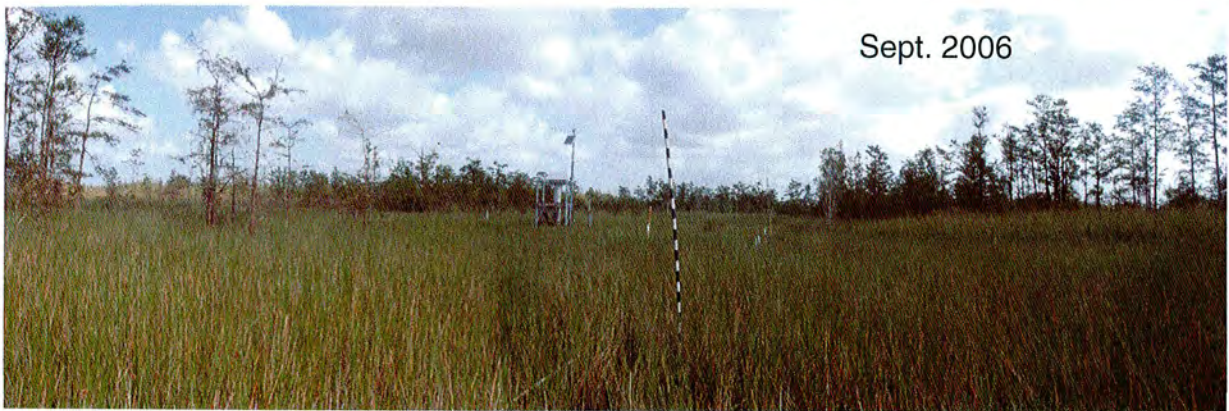
Photostation 1 – Swale

Stations 1-3 are situated in swale communities dominated by spikerush (*Eleocharis cellulosa*) with very little shrub layer and virtually no canopy layer. Station 4 is a mature hydric hammock dominated by wild coffee (*Psychotria nervosa*) and swamp fern (*Blechnum serrulatum*) in the understory, and cabbage palm (*Sabal palmetto*) and laurel oak (*Quercus laurifolia*) in the canopy layer. The herbaceous layer is very sparse and severely damaged (tilled) by feral hogs (*Sus scrofa*). Station 5 is comprised of wet flatwoods where the herbaceous layer is highly variable, the shrub layer is dominated by cabbage palms and myrsine (*Rapanea punctata*), and the canopy is dominated by slash pine (*Pinus elliottii* var. *densa*). Surface water is generally not present at Stations 4 and 5 during the wet or dry seasons, however during the 2009 wet season monitoring, Station 4 was saturated and Station 5 had standing water at one of the plots. Panoramic photographs were taken at each of the five photopoint locations to give both quantitative (shrub and herbaceous layer heights) and qualitative representations of the vegetative community types described above.
