# **Appendix 5-1: Annual Permit Report for the North Palm Beach County – Part 1 Project, G-160 and G-161 Components**

**Permit Report (Operational Year 2010)  
Permit Numbers: EI 50-0128848-004 and EI-0244327-002**

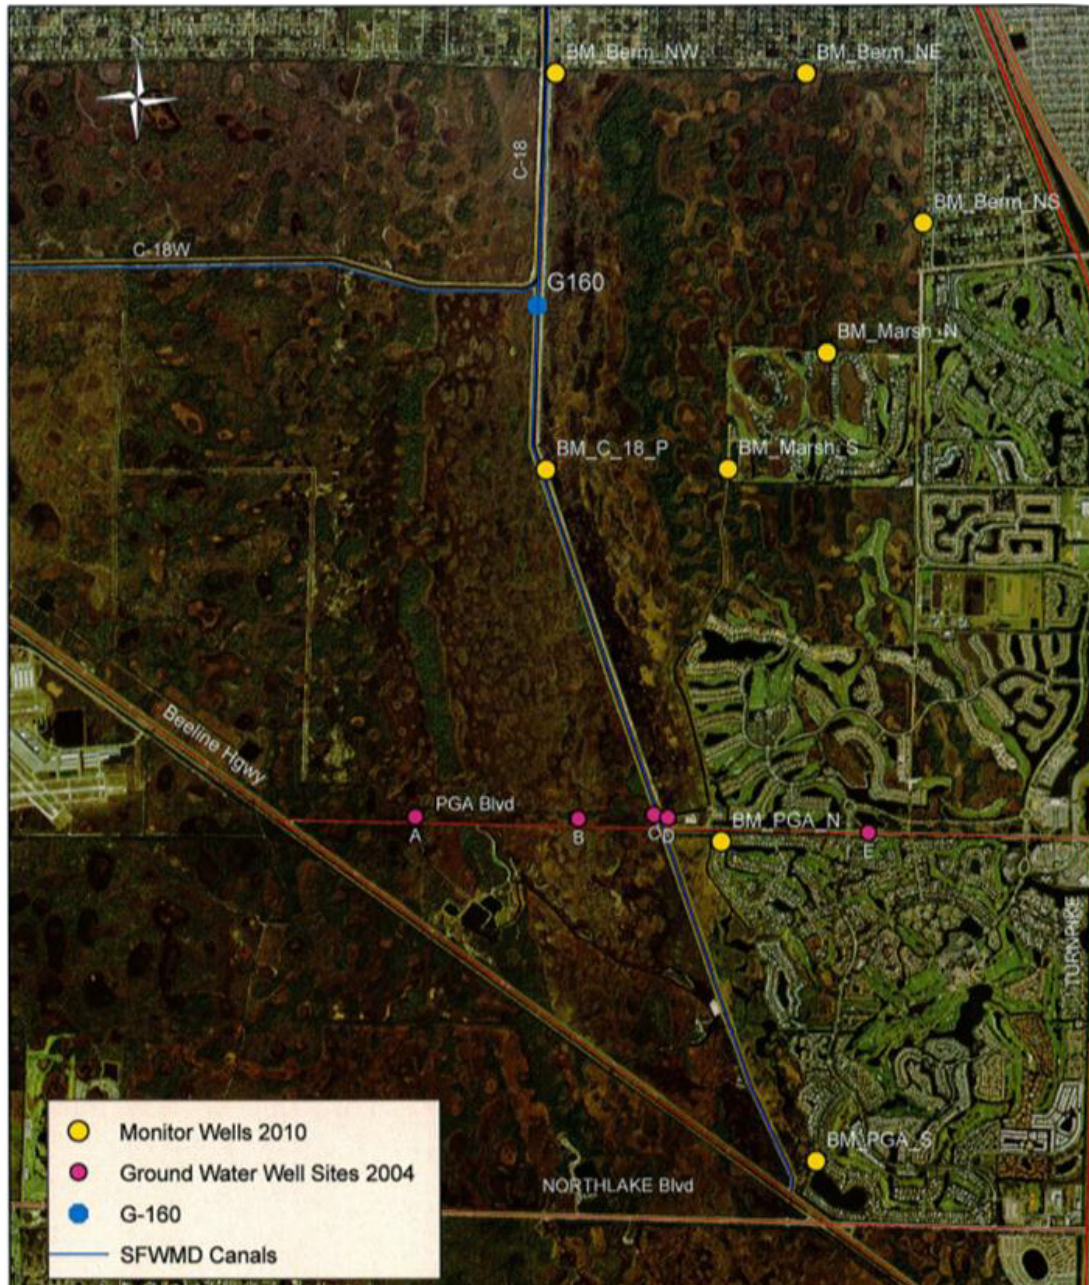
**Figure 2.** Groundwater monitoring wells.

Several communities are located on the east side of the C-18 canal, within the historic Loxahatchee Slough. These include Old Marsh, East Point, Mirasol and the city of Palm Beach Gardens. These communities are served by the Northern Palm Beach County Improvement District (NPBCID), a Chapter 298 District that provides storm water management and other necessary public services. Palm Beach Country Estates is located north and east of the east Loxahatchee slough, and is served by the South Indian River Water Control District (SIRWCD). Though accepting the results of the Taylor Engineering modeling effort, NPBCID, SIRWCD and the city of Palm Beach Gardens expressed concerns with the proposed operational schedule for the structure, specifically in terms of what additional seepage might be expected with the elevated stage in the C-18 canal and concurrent slough stages, and what affect that seepage could have on specific roads within the developments, as well as to soil storage relationships within the developments. There were also concerns raised regarding whether or not increased seepage would occur through the northern and eastern SIRWCD berms that separate the Loxahatchee Slough from the Palm Beach Country Estates subdivision. In response to these concerns, the agencies entered into a 4-party agreement in 2005, in which the SFWMD agreed to maintain the G-160 stage at 15.0 ft NGVD in the dry season and 15.5 ft NGVD in the wet season for a period of 5 years, while executing a second agreement with NPBCID to assess the issues of concern and determine if specific mitigation measures were necessary to offset seepage related impacts. With this second agreement, survey and geotechnical data related to roadways, berms and facilities within the communities were collected, and a seepage curve was constructed (see **Figure 2**).
