# Appendix 5-3:

## Annual Permit Report for the C-4 Emergency Detention Basin

Permit Report (May 1, 2011–April 30, 2012)

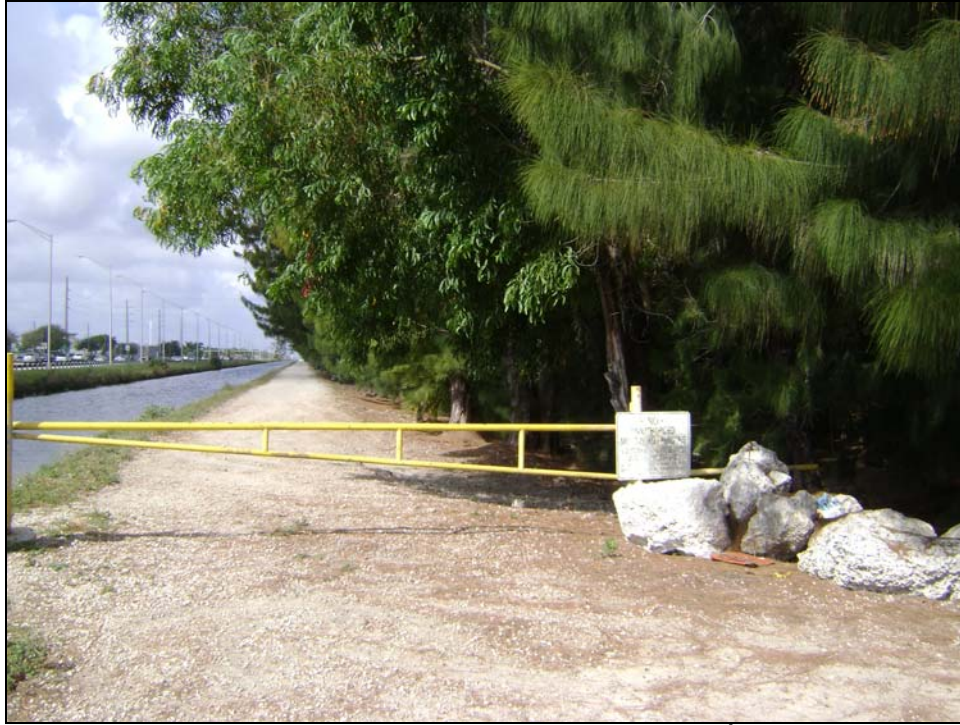
The unpaved road from SW 137<sup>th</sup> Avenue is in an acceptable condition. There were no ruts observed and the Melaleuca and Australian Pine trees on the vacant property located on the north side of the road do not impede access to the Basin (Figure 3). The District's Miami Field Station staff regularly graded the access road.

Figure 3. Westerly view of the unpaved access road from SW 137<sup>th</sup> Avenue.

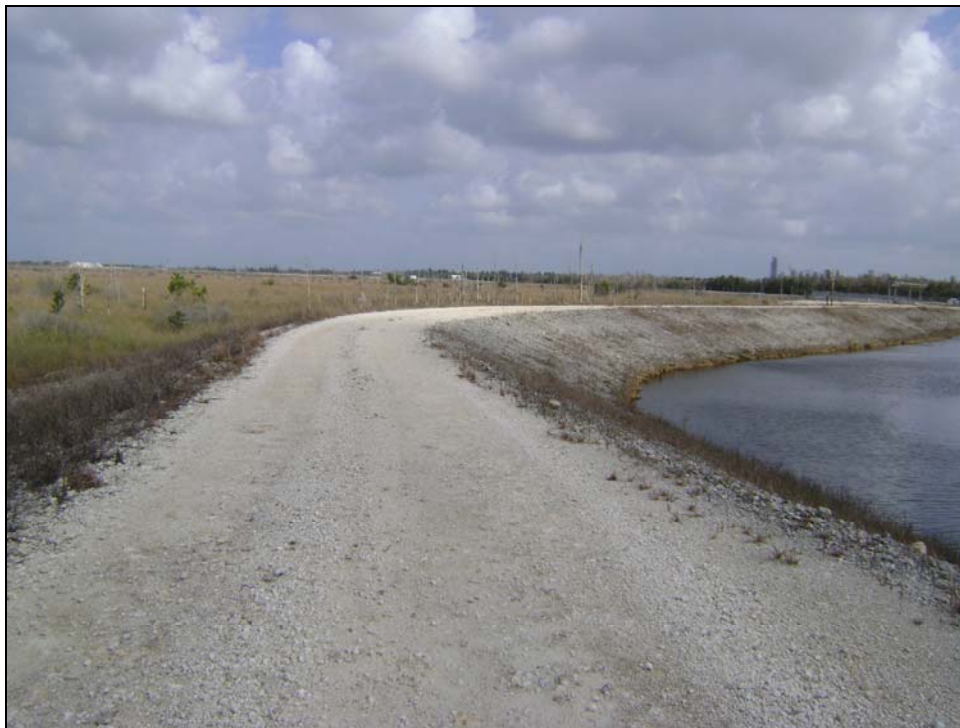
Figure 4. Northerly view of the 14-foot wide East Perimeter Levee and the Supply Canal from the southeast corner of the South Cell. The inside and outside slopes are 4H:1V and 2.5H:1V, respectively. The majority of the side slopes are bare of vegetation. The weeds on the slopes are withered. No ruts or erosion was observed.

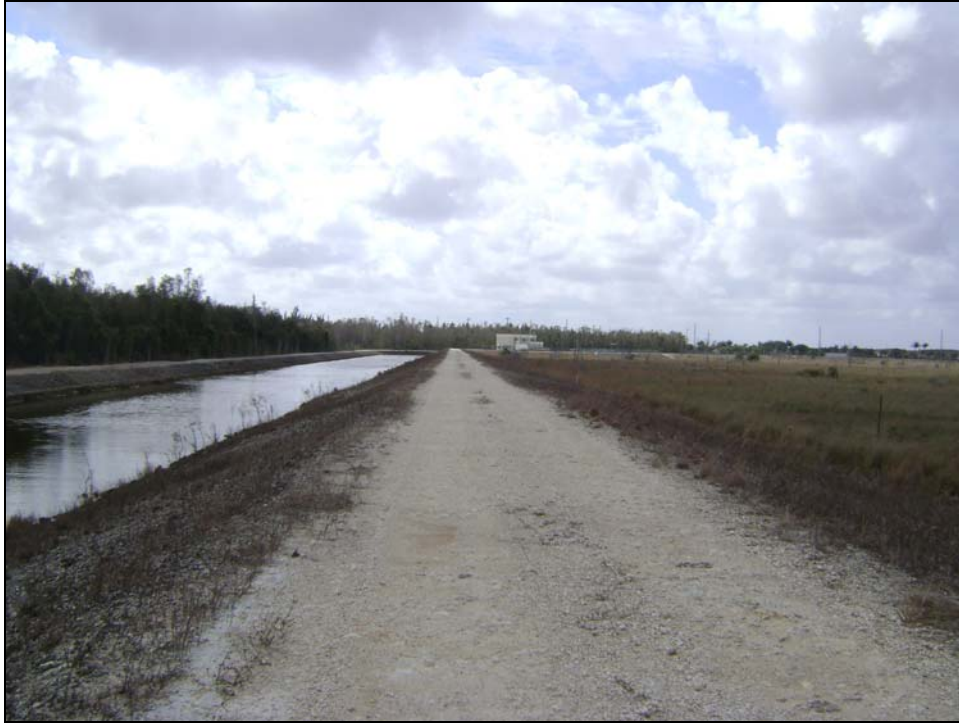
Figure 5. Southerly view of the 14-foot wide East Perimeter Levee 0.28 miles north of the G-422 Pump Station. The inside and outside slopes are 4H:1V and 2.5H:1V, respectively. Majority of the side slopes are bare of vegetation. The weeds on the slopes are withered. No ruts or erosion was observed.

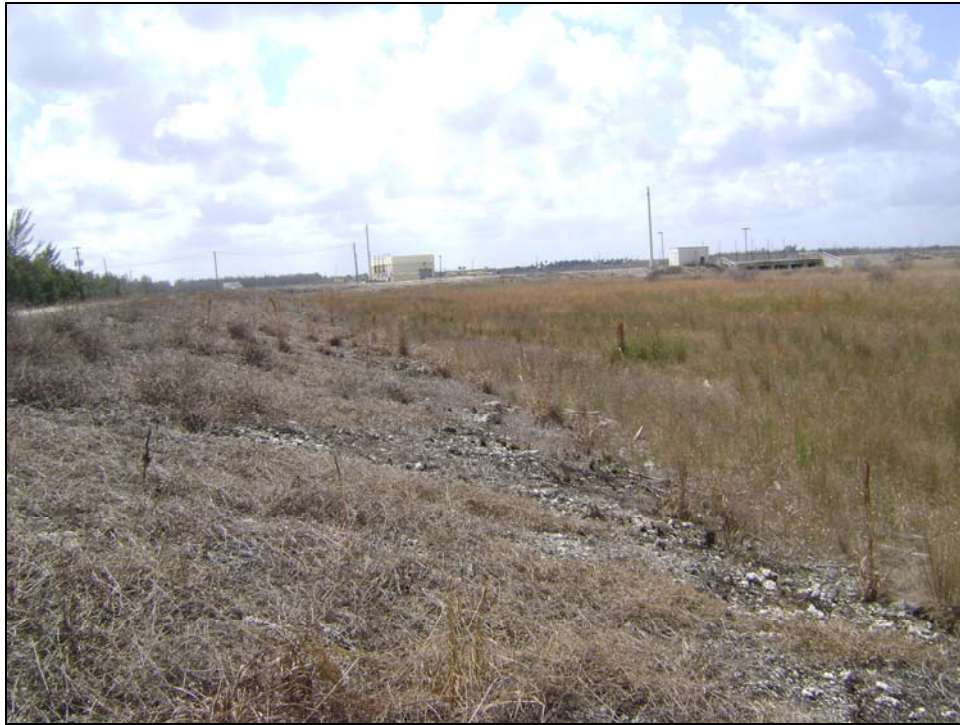
Figure 7. Southerly view of the North Cell Perimeter Levee inside slope 0.2 miles north of the intersection of the Interior Levee and the North Perimeter Levee. The 4H:1V inside slope has a mixture of 6" muck and limestone gravel and boulders with withered vegetation cover. No ruts or erosion was observed.

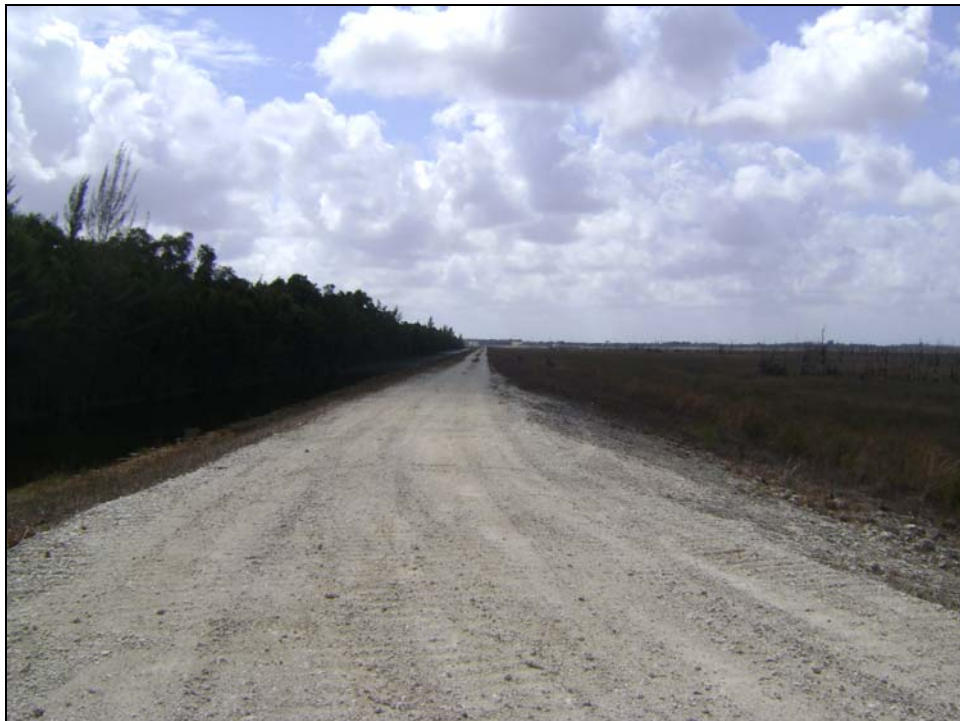
Figure 8. Southerly view of the North Cell Perimeter Levee as seen from the northeast corner of the North Cell. The inside and outside slopes are 4H:1V and 2H:1V, respectively. Vegetation on the slopes is withered. No ruts and erosion observed.

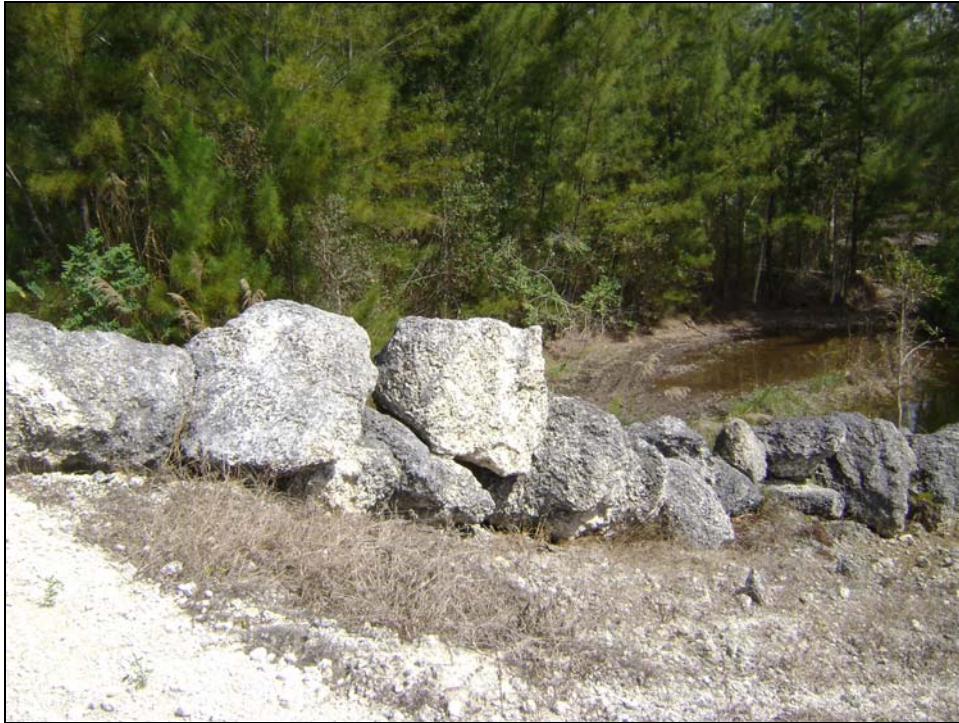
Figure 9. Northeasterly view of the 3-foot boulders installed at the northeast corner of the North Cell to prevent motorized vehicles from entering the C-4 Emergency Detention Basin.

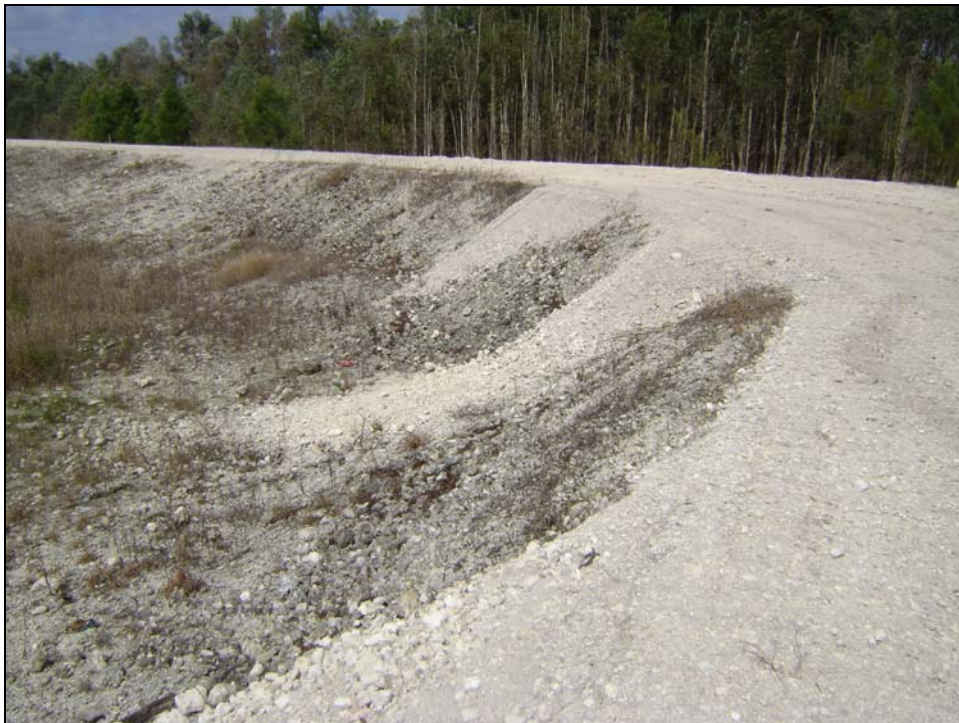
Figure 10. Northwesterly view of the northeast corner of the North Cell Perimeter Levee. The levee width is approximately 30- feet wide at this corner with the inside slopes at 0.75H:1V which will require flattening. Sparse vegetation on the slopes is withered. No ruts and erosion observed.

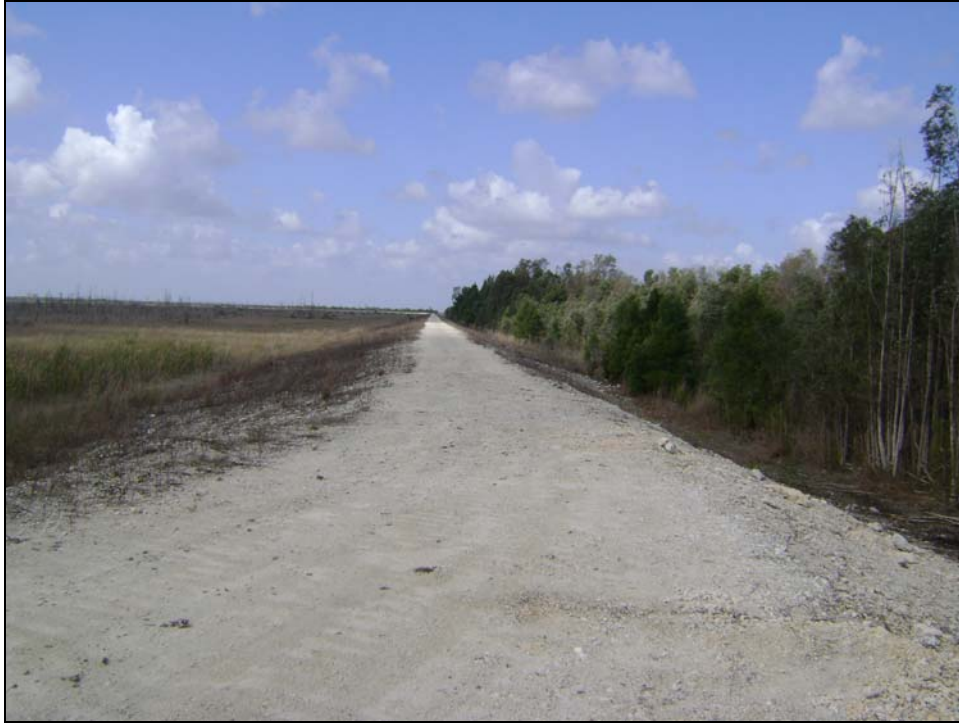
Figure 11. Westerly view of the North Cell North Perimeter Levee as seen from the northeast corner. The inside and outside slopes are 4H:1V and 2.5H:1V, respectively. Sparse vegetation noted and is withered. No ruts or erosion was observed.

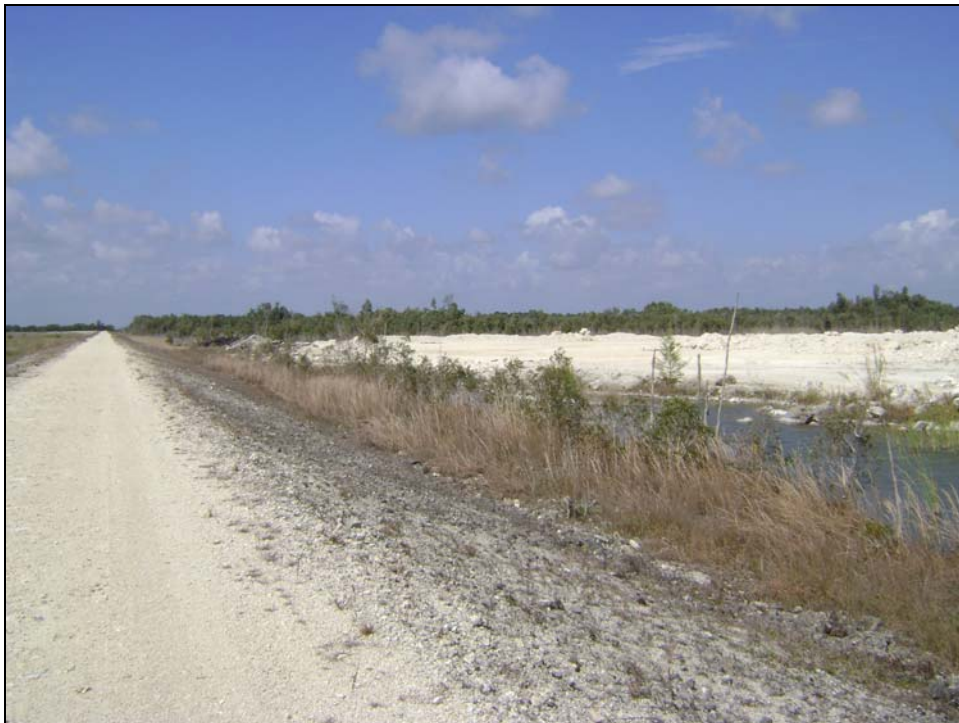
Figure 12. Westerly view of the North Cell North Perimeter Levee and the CEMEX Mines, 0.4 miles west of the northeast corner of the Basin. The inside and outside slopes are 4H:1V and 2.5H:1V, respectively. Sparse withered vegetation noted. No ruts or erosion was observed.

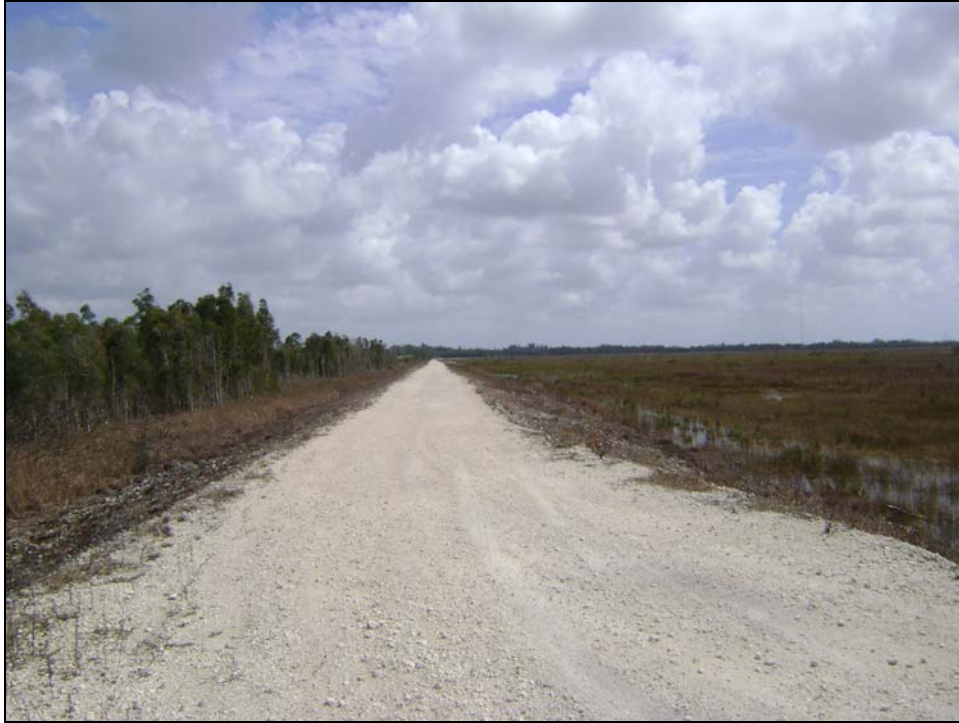
Figure 13. Easterly view of the North Cell North Perimeter Levee as seen from the northwest corner of the Basin. At this corner the levee top transitions into a 25 to 30-foot wide West Perimeter levee. The inside and outside slopes are 4H:1V and 2.5H:1V, respectively. Sparse withered vegetation noted. No ruts or erosion was observed.

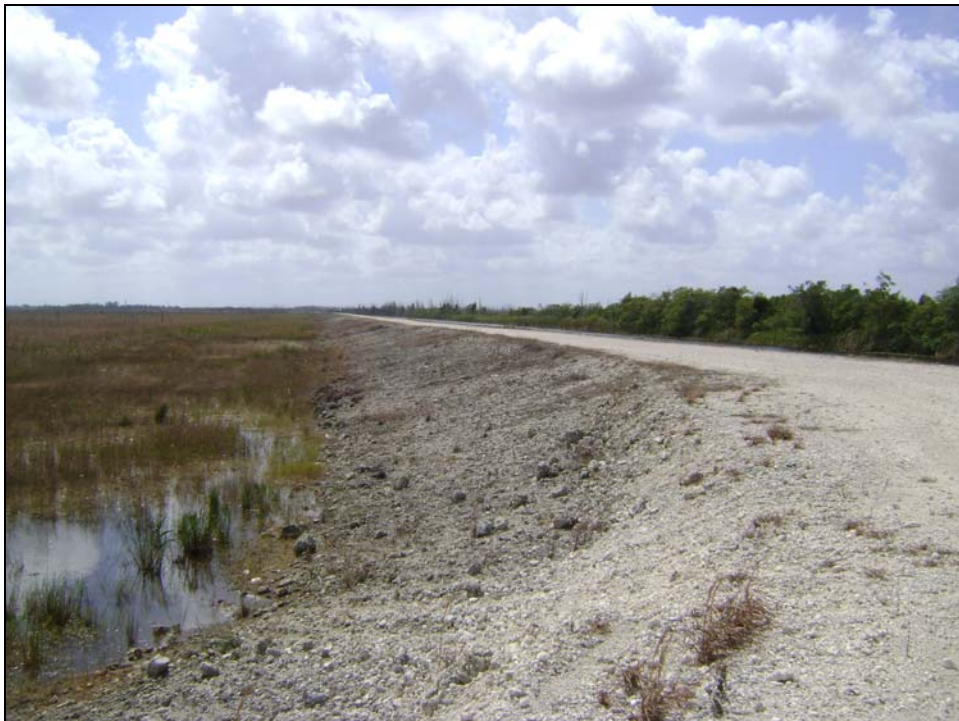
Figure 14. Southerly view of the North Cell West Perimeter Levee as seen from the northwest corner. The inside and outside slopes are 4H:1V and 1H:1V, respectively. Sparse withered vegetation noted. No ruts or erosion was observed.

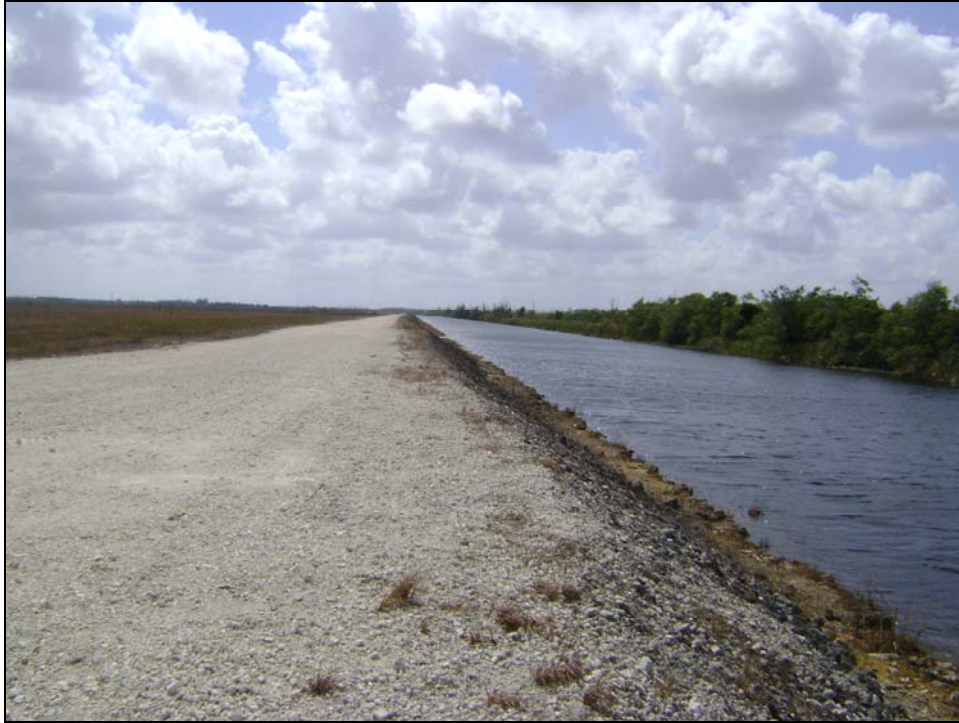
Figure 15. Southerly view of the North Cell West Perimeter Levee and Borrow Pit as seen from the northwest corner. The outside slope is 1H:1V. Sparse withered vegetation noted. No ruts or erosion was observed.

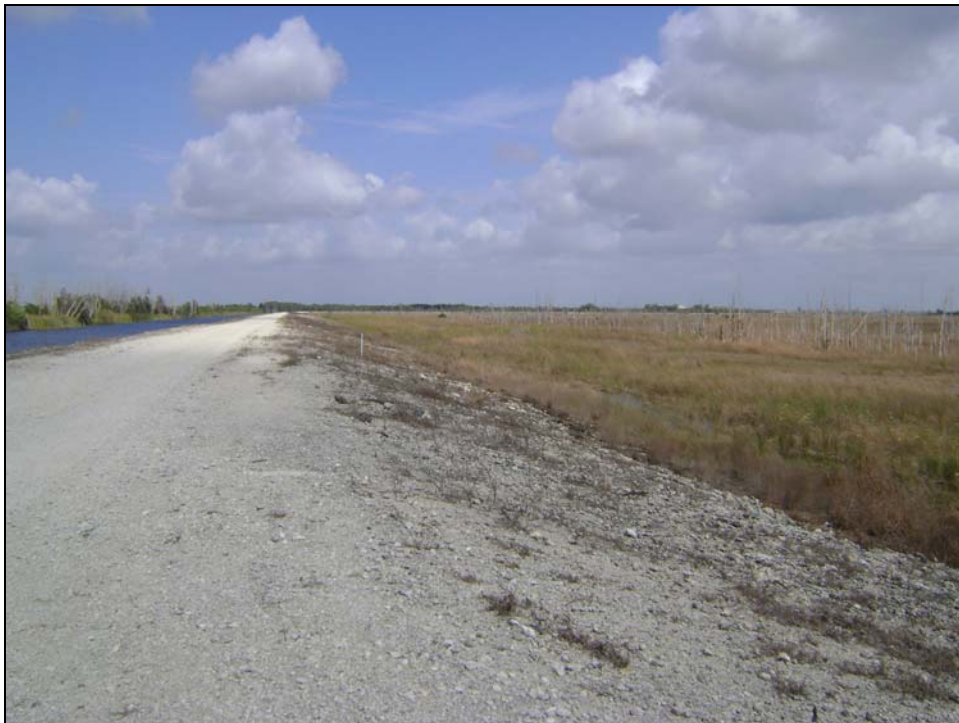
Figure 16. Northerly view of the 25-foot wide North Cell West Perimeter Levee as seen from its junction with the Interior Levee. The inside and outside slopes are 4H:1V and 1H:1V, respectively. Sparse withered vegetation noted. No ruts or erosion was observed.

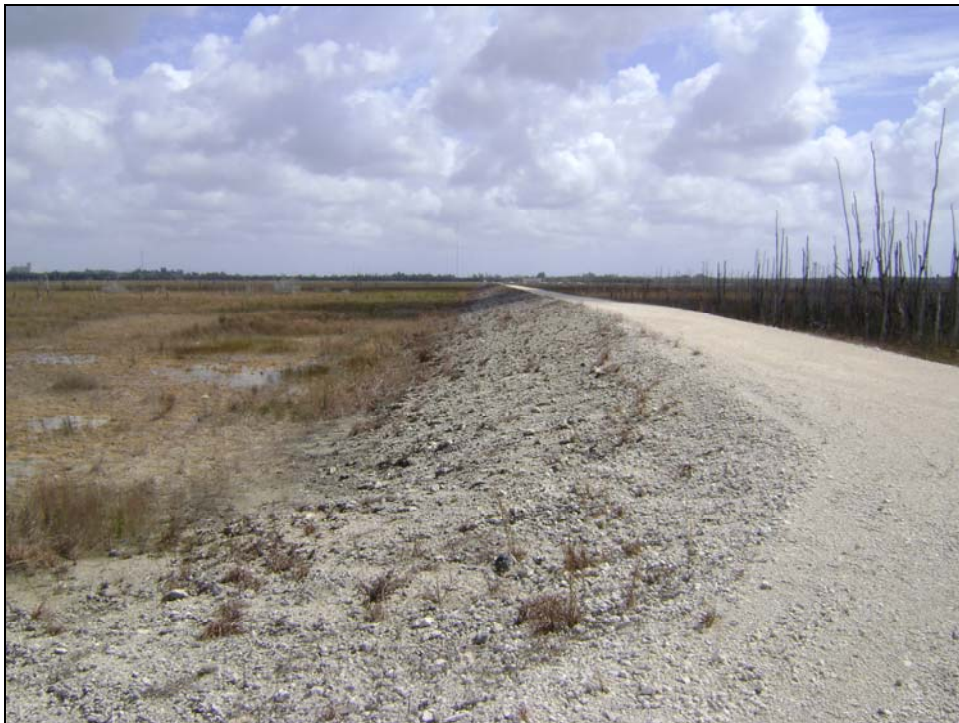
Figure 18. Easterly view of the 10-foot wide Interior Levee between the North and South Cells. The levee slope is 4H:1V. Sparse withered vegetation noted. No ruts or erosion was observed.

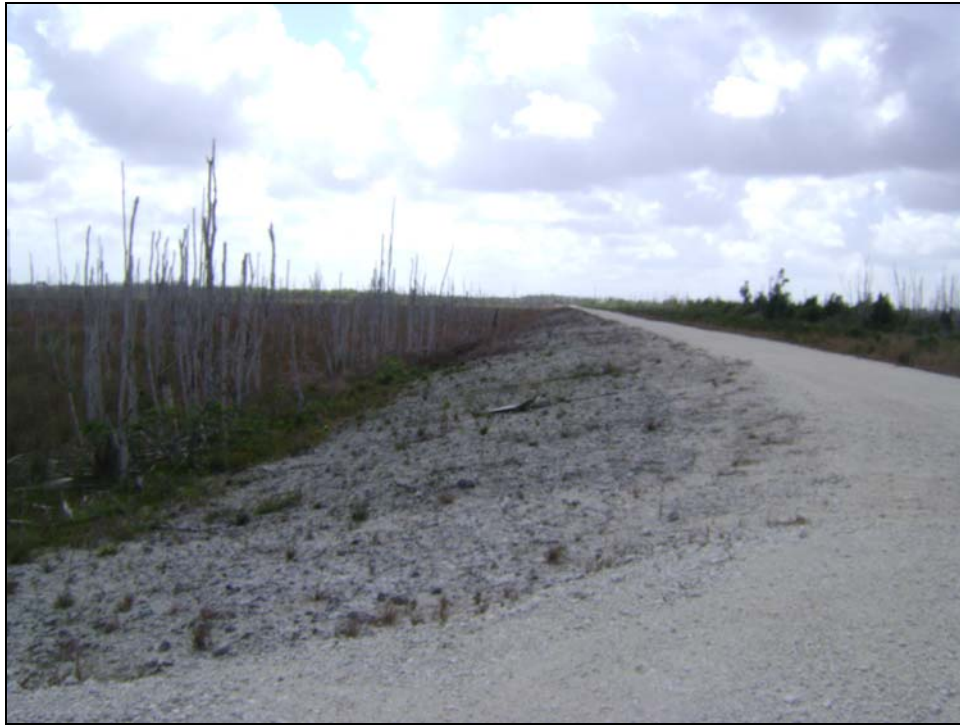
Figure 19. Southerly view of the 14-foot wide South Cell West Perimeter Levee as seen from its junction with the Interior Levee. The inside and outside slopes are 4H:1V and 2H:1V, respectively. Sparse withered vegetation noted. No ruts or erosion was observed.

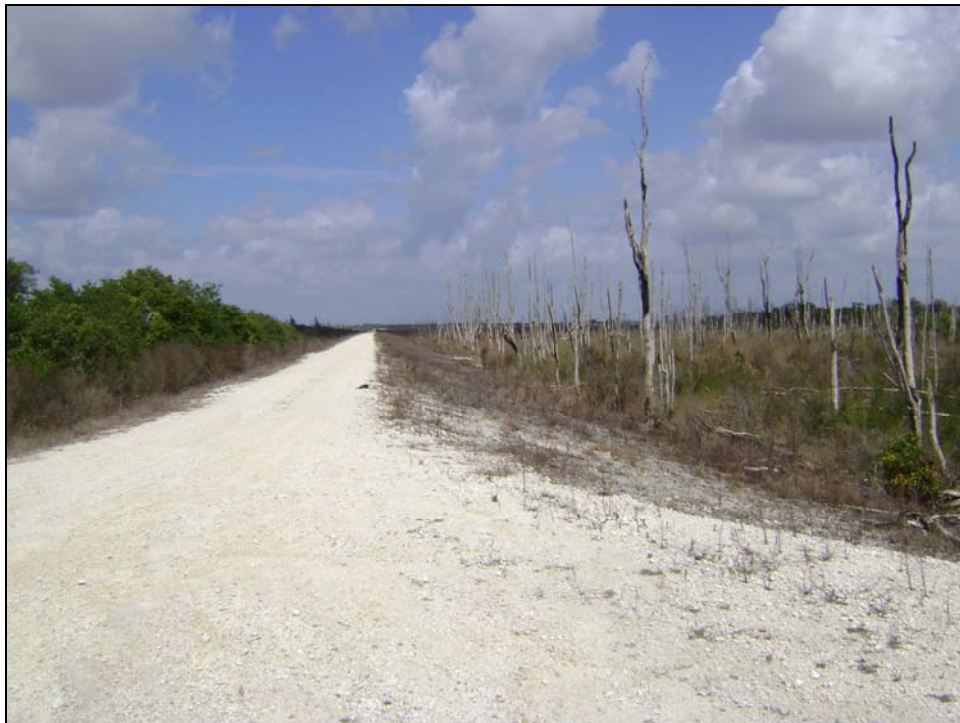
Figure 20. Northerly view of the 14-foot wide South Cell West Perimeter Levee as seen from the southwest corner. The inside and outside slopes are 4H:1V and 2H:1V, respectively. Sparse withered vegetation noted. No ruts or erosion was observed.

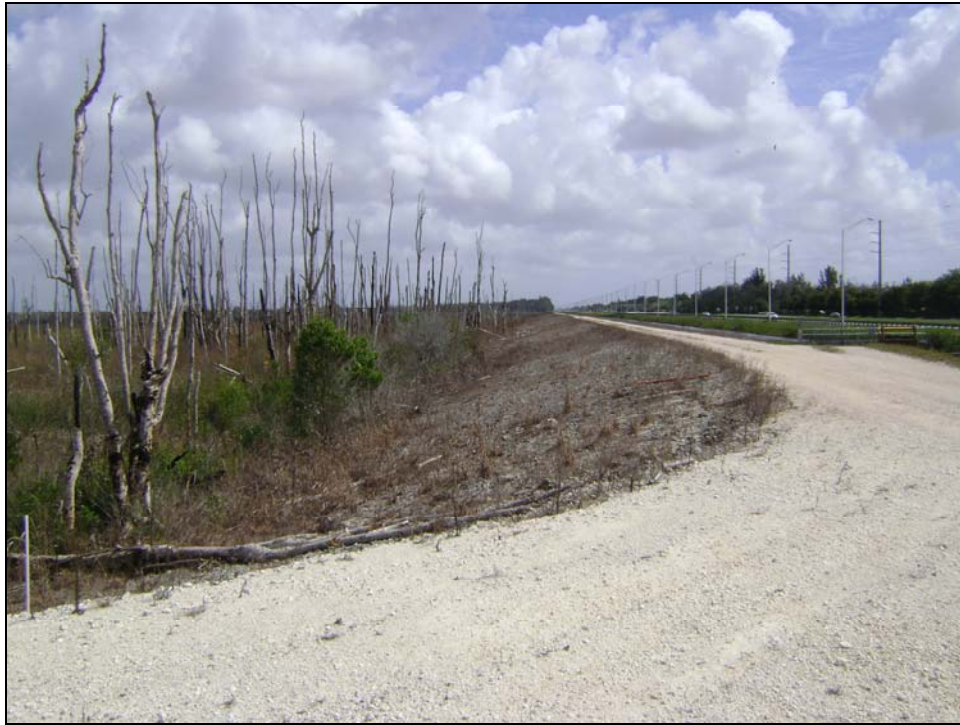
Figure 21. Easterly view of the 14-foot wide South Cell South Perimeter Levee as seen from southwest corner. The inside and outside slopes are 4H:1V and 2H:1V, respectively. Sparse withered vegetation noted. No ruts or erosion was observed.

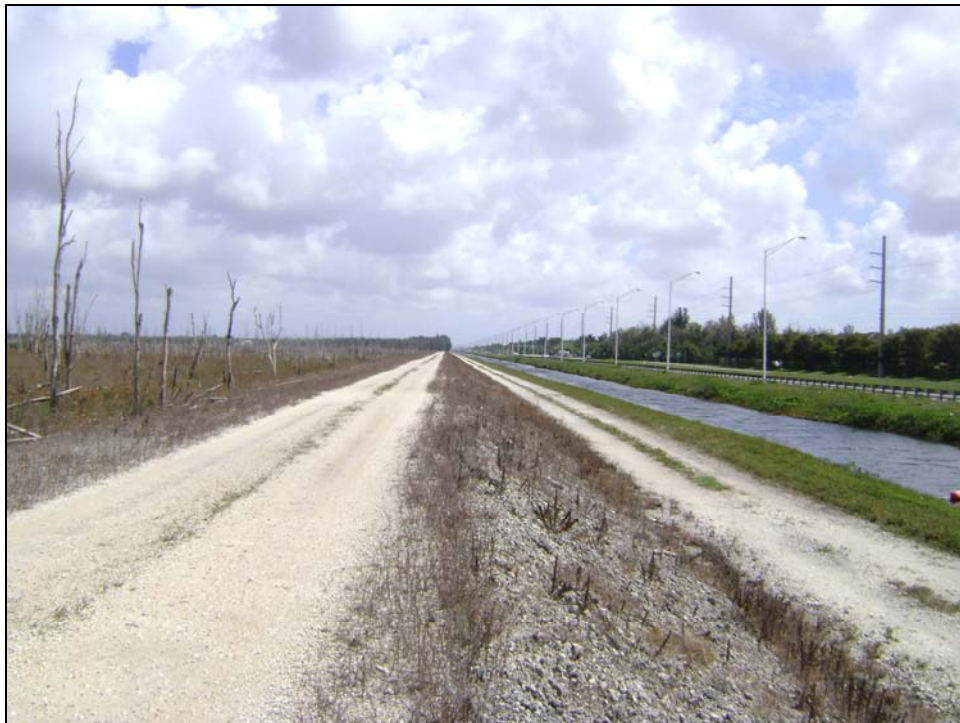
Figure 22. Easterly view of the 14-foot wide South Cell South Perimeter Levee and 25-foot wide berm approximately 200 feet east of the southwest corner. The inside and outside slopes are 4H:1V and 2H:1V, respectively. Sparse withered vegetation noted. No ruts or erosion was observed.

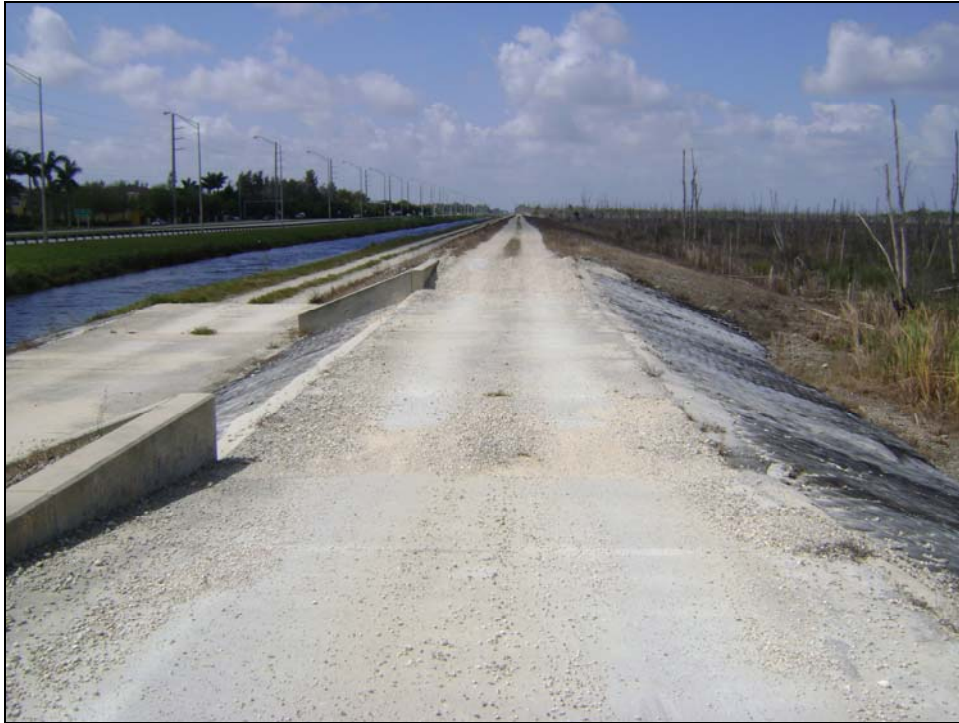
The Emergency Spillway structure is constructed of a reinforced concrete slab and retaining wall with fabriform concrete matting on the side slopes (Figures 23 and 24). There is no erosion observed at the adjacent embankment and toe and there was no maintenance work performed on the emergency spillway in 2011. Except for the withered vegetation growing in the construction joints, the structure is in an acceptable condition. Future maintenance work is the removal of the vegetation.

Figure 23. Westerly view of the Emergency Spillway. The concrete surface is in good condition. Some vegetation growth along the construction joints.

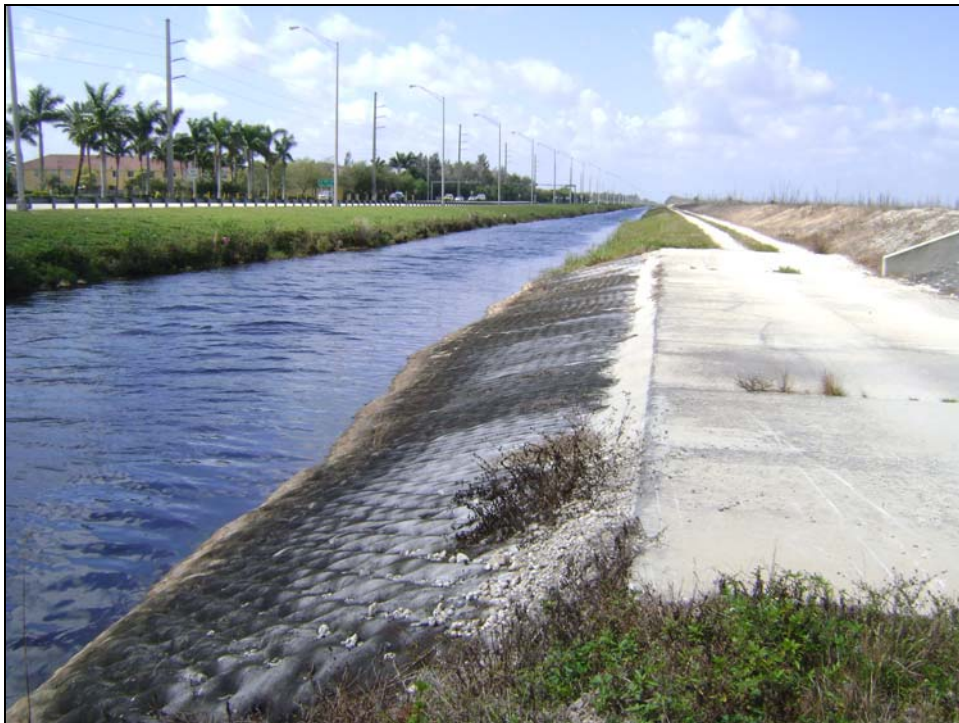
Figure 24. Closer view of the Emergency Spillway showing some vegetation growing along construction joints and fabriform joints.

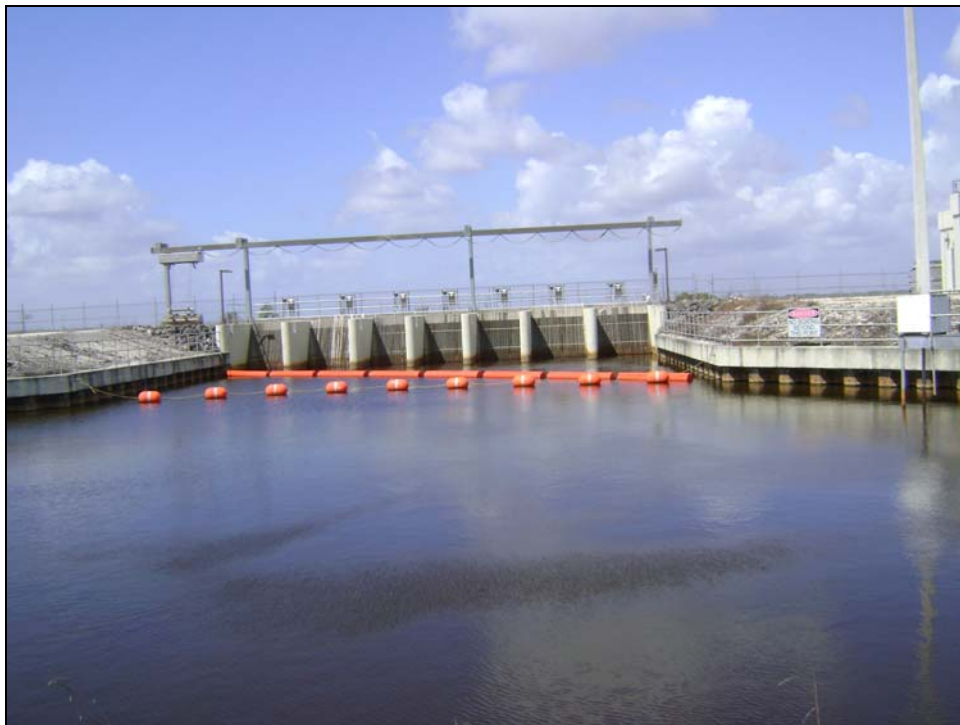
Figure 26. Westerly view of the G-422 Intake Pump Station showing the trash rake system and seven pump bays with 89cfs electric pumps. The concrete abutments and steel sheet pile walls are in good condition.

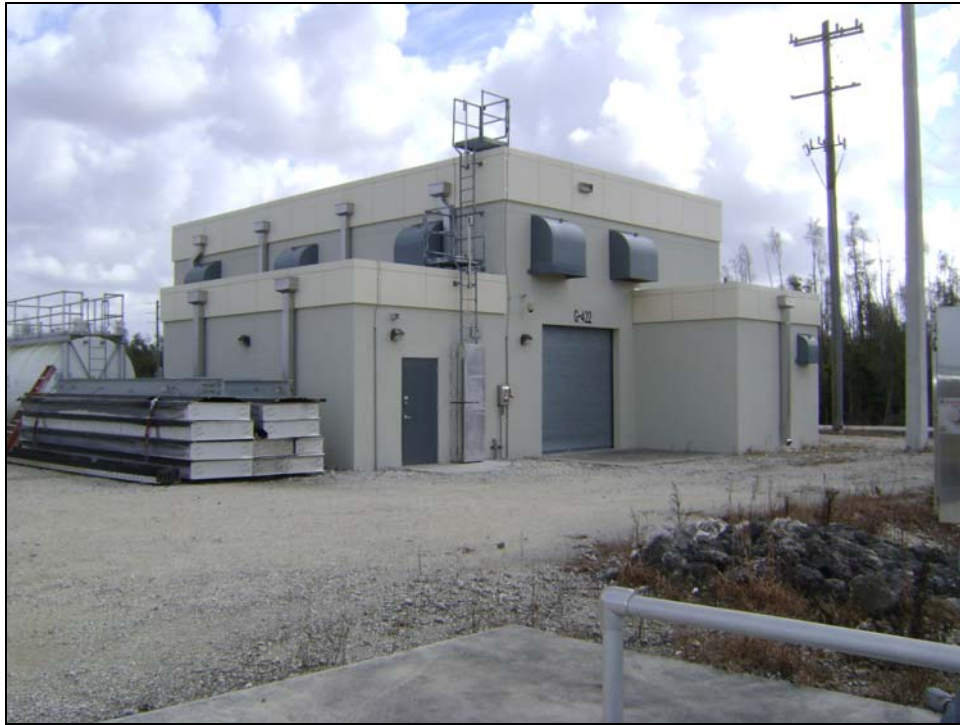
Figure 27. Northeasterly view of the G-422 Intake Pump Station Emergency Generator Building. The roof was repaired in 2011.

There are no erosion or cracked concrete surfaces observed on the structures (Figures 25 to 35) that abut the embankment. Minimal iron oxide stains were observed on the walls. Regular preventive maintenance work was performed on these structures. Repairs of the G-422 and G420 roofs were completed in 2011. These structures are in acceptable condition.

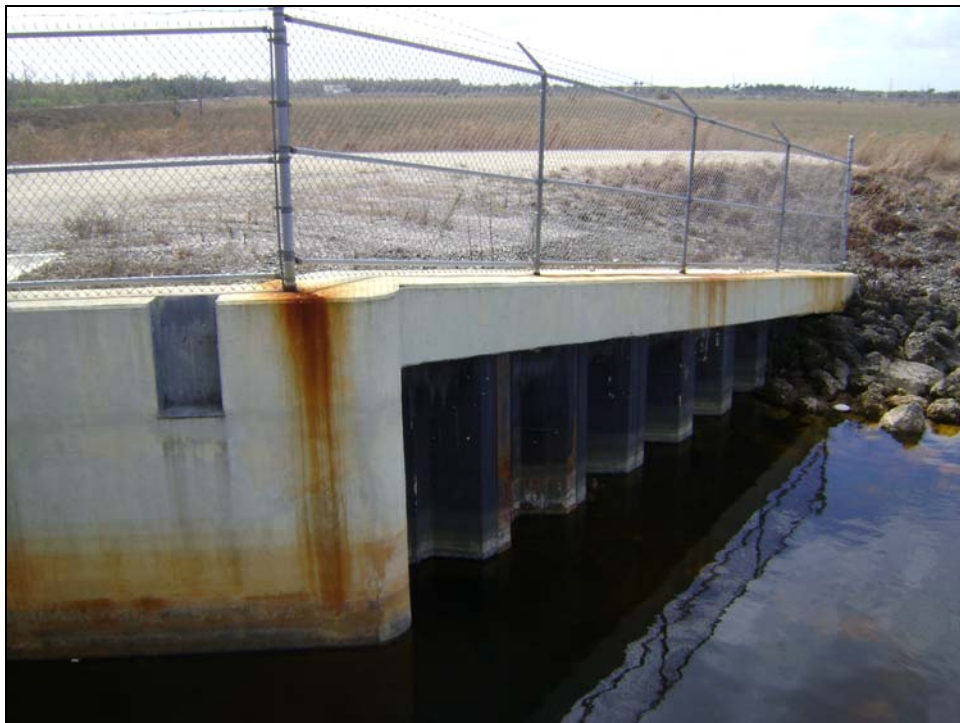
Figure 28. Southwesterly view of the G-421 Gated Spillway Structure Wingwall. Iron oxide stains from minor corrosion of fence posts. No cracks were observed on the concrete surfaces.

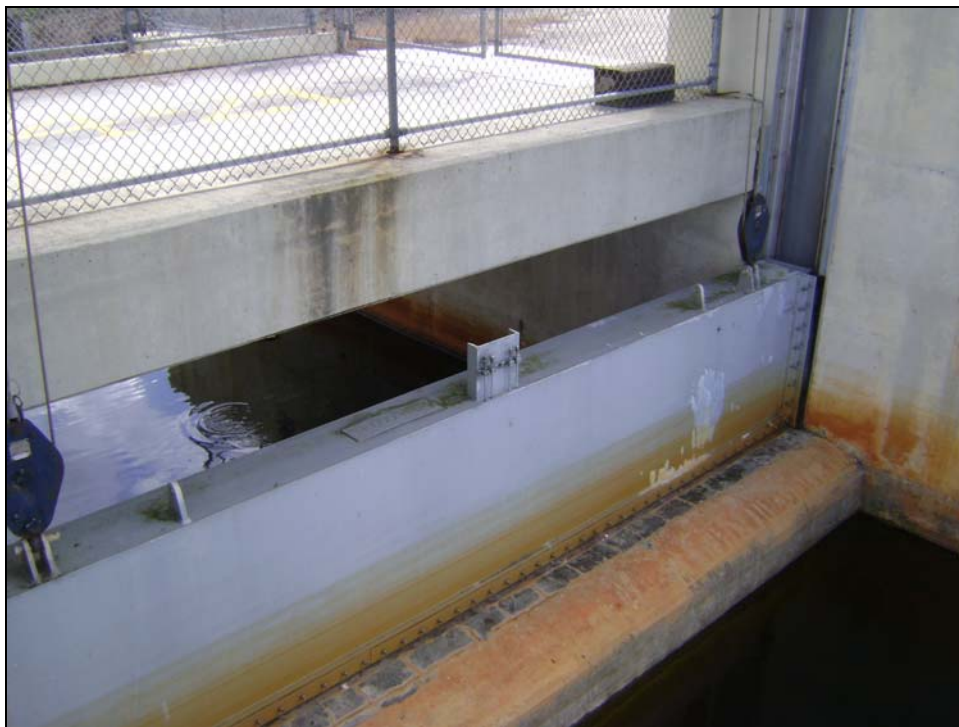
Figure 29. View of the G-421 Gated Spillway Structure vertical roller gate and weir crest.

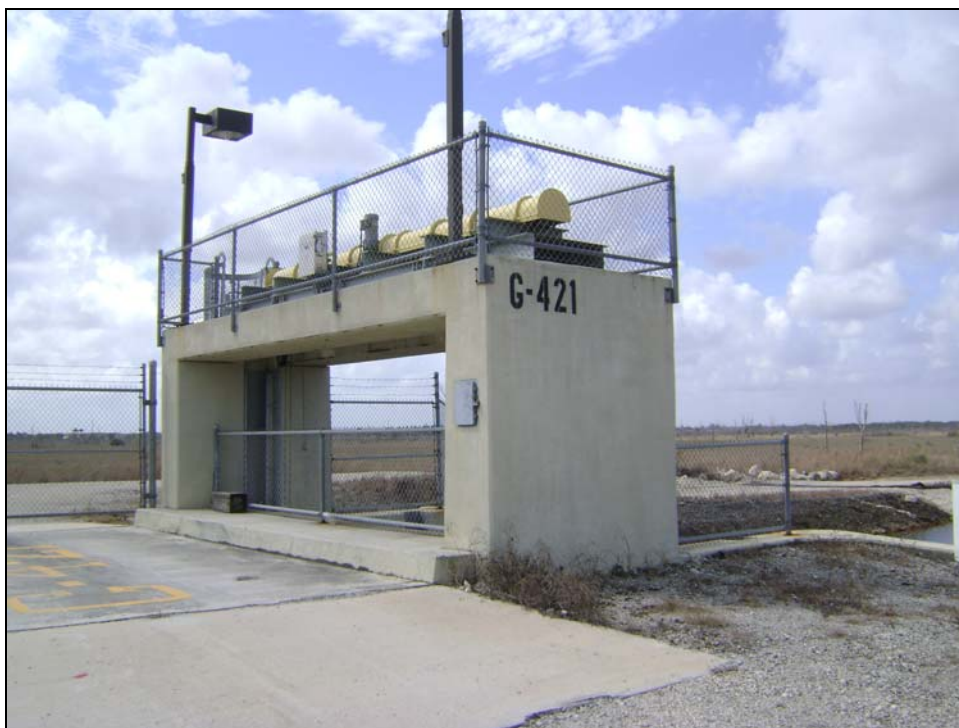
Figure 30. View of the G-421 Gated Spillway Structure service bridge. No cracks observed on the concrete surfaces.

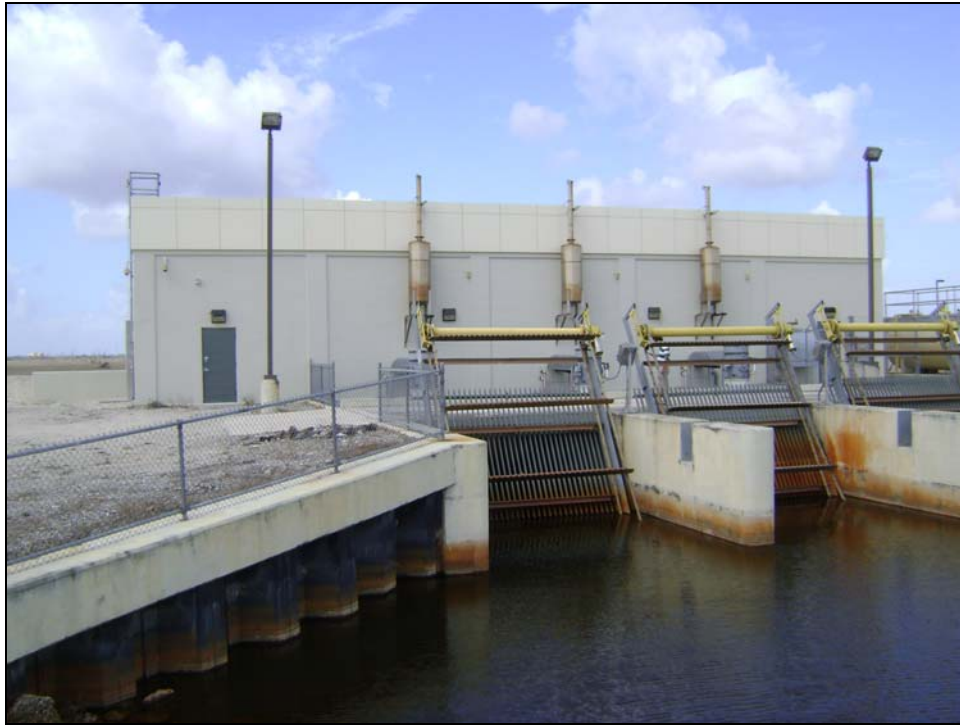
Figure 31. Westerly view of the G-420 Intake Pump Station showing the trash rake system and three pump bays with 223cfs electric pumps. The concrete abutments and steel sheet pile walls are in good condition.

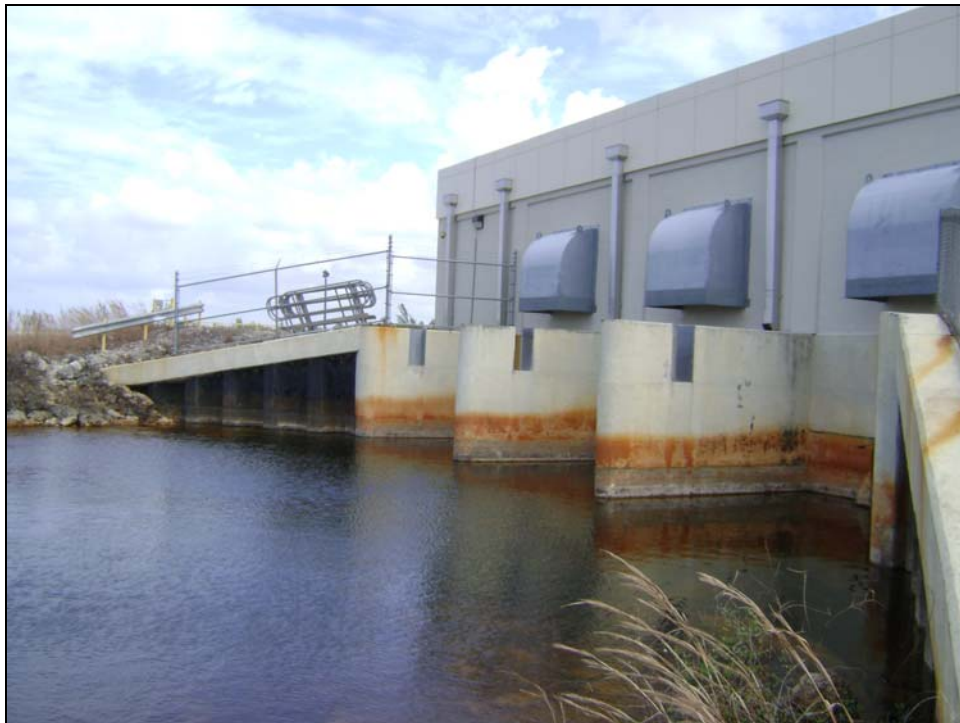
Figure 32. Northeasterly view of the G-420 Intake Pump Station showing the discharge bays. The concrete abutments and steel sheet pile walls are in good condition.

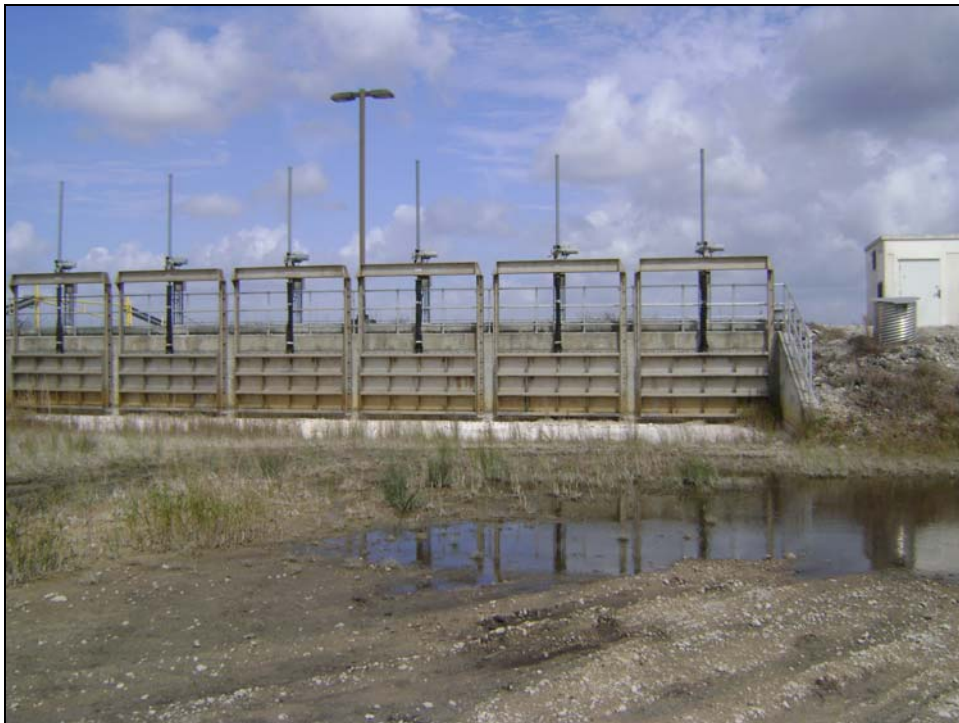
Figure 36. Northerly view of the G-423 Interbasin Transfer Structure with six 5-foot high by 10-foot wide gated culverts.

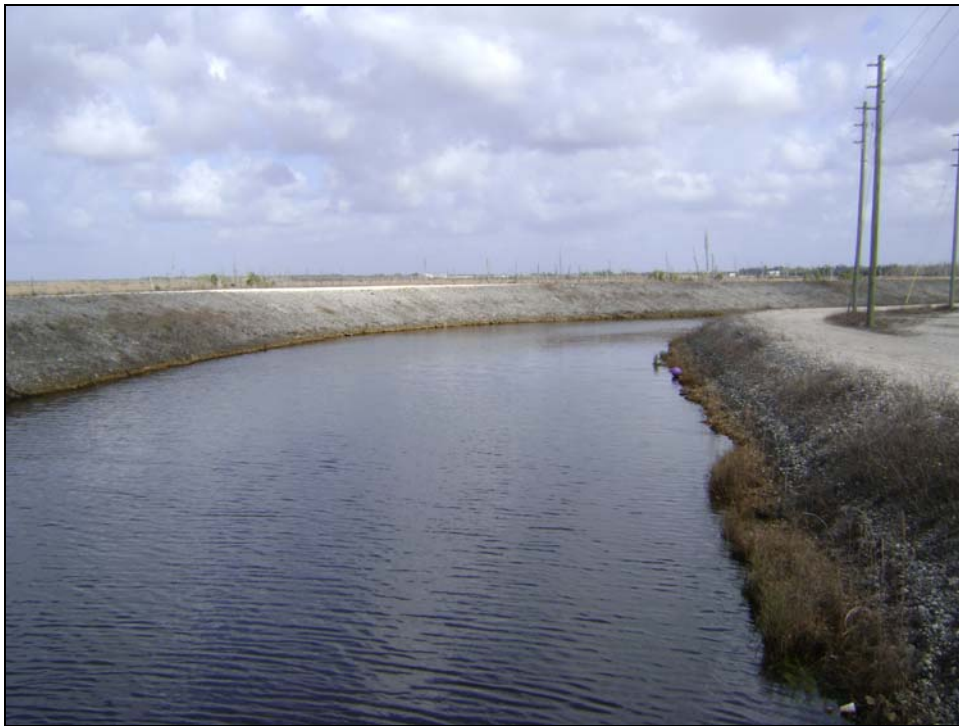
There are no erosion or slope failures observed on the banks of the Supply Canal. Although there is no vegetative cover on the canal banks, it is in limestone and constructed of crushed limestone, hence it is stable. The Supply Canal is in an acceptable condition.

Figure 38. Northerly view of the Supply Canal as seen from the access bridge. There are no erosion or slope failure observed on the canal banks.
